# 2 Year Follow-up on Full Thickness, non-retracted Rotator Cuff Tear Treated with Stem Cells

In keeping with some of the long-term treatment updates of our study patients this past week, this is the case of an elderly woman with a full thickness tear of her rotator cuff who had 100% relief through the injection of her own stem cells into the tear rather than surgery. The patient had severe pain and was basically unable to lift her shoulder. Because the tear wasn't retracted (the two ends of the tears were still together), she was placed into one of our studies as she was high risk for surgery. We injected her own cultured stem cells into the tears under imaging guidance. She had fairly rapid (1-3 months) complete recovery with return of full function of the shoulder and she needed no immobilization (blue pillow and sling). The big question was if this result would hold or if the repair tissue was flimsy and would soon re-tear. Here is her 2 year MRI. She is still reporting 100% resolution of her symptoms (she's now 80 years old) and her MRI shows that her rotator cuff tears still look largely resolved. To better understand what happened with her MRI and why it looks better now (a

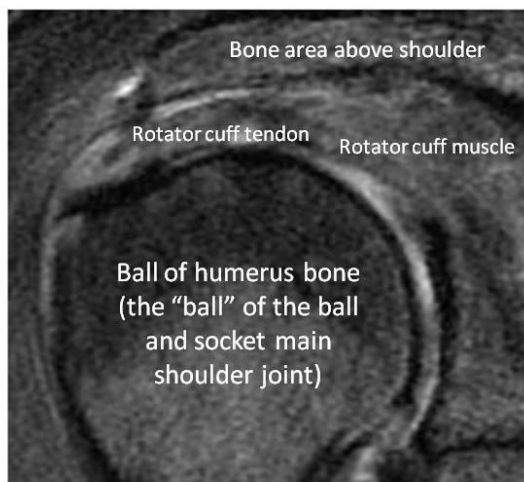
## 2.04.2008 COR MRI

COR MRI. ET=7, TR=2350, TE=62.2

Acetebulum or shoulder joint socket

The image above is this patient's pre-injection coronal MRI. A coronal MRI slice is one that lets you look from the front or the back. Here you can see the MRI on the left and the diagram of the MRI to the right. The rotator cuff tendon is the area of interest. The rotator cuff like any muscle has two parts, the muscle belly and the part that attaches the muscle to the bone, the muscle tendon. Rotator cuff tears commonly occur at the muscle tendon area. In addition, MRI images

come in many different flavors, some show water as bright or a lighter color, which is what's being shown here in these PDFS sequences. So on this image, a darker appearing tendon is good, one with light spots in it is bad. A normal rotator cuff tendon in this type of MRI sequence would be a uniform darker color or black (depending on age).

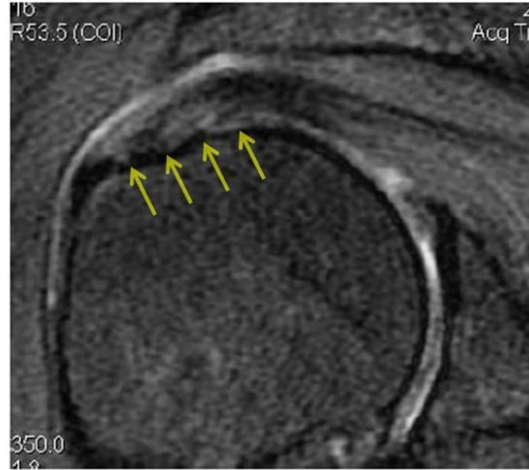
### 6.24.2010 COR MRI

COR MRI. ET=7, TR=2350, TE= 62

Now for the patient MRI's. Above on the left is an MRI taken 2 months before her stem cell injection in April 2008, the image on the right is her 2 year follow-up MRI. The left MRI shows the rotator cuff tendon (red arrows) which is bright in color and mottled in appearance. This means that it's a full thickness rotator cuff tendon tear with severe degeneration (she's 78 years old at the time of this picture). To the right is her two year follow-up MRI showing a darker appearing rotator cuff tendon (yellow arrows) without any light color that goes all the way through the tendon (she's 80 years old in this picture). Clearly an improvement that's still holding and demonstrated not only by her reports of no pain and full function, but also objective MRI imaging two years later.
